GROUND DAMAGE RESULTING FROM TORRENTIAL  
RAINS IN FUKUI, JULY 2004THE JAPANESE GEOTECHNICAL SOCIETY: EMERGENCY SURVEY TEAM FOR GROUND DAMAGE  
RESULTING FROM TORRENTIAL RAINS IN FUKUI, JULY 2004

Torrential rains in Fukui, July 2004 resulted in heavy damage to ground in the Asuwa river basin. This paper reports an outline of the matters and causes of the following damage: 1) The dike in the lower reaches of Asuwa river was breached in city area. A detailed survey was undertaken to determine why the dike was breached at that location. 2) Many cases of damage to revetments were observed in the upper reaches of Asuwa river and its tributary streams, and the damage was worsened by inundation resulting from timber debris and sedimentation. There were many cases of slope failure above revetments, which were thought to be due to scouring. 3) Many slope failures occurred at locations distant from rivers. In many cases they were relatively shallow collapses. 4) Many mud and debris flows occurred along small rivers or in mountain valleys, and large quantities of mud and timber were displaced. 5) At five steel bridges on the JR Line, bridge girders were washed away and bridge supports collap

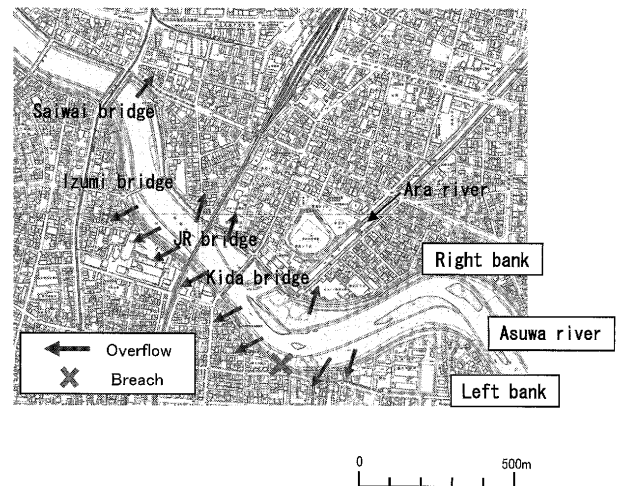
Fig. 4. Places of overflow and breach on dike (lower reach of Asuwa river)

Figure 4 shows the locations of overflow and dike breach in the lower reaches of Asuwa river (inner Fukui city area). On the left bank, overflow occurred over approximately 900 m, from Izumi bridge to upstream of the dike breach. On the right bank, overflow occurred in 4 locations. In the following descriptions, the locations show the distances upstream of the confluence of Asuwa and Hino rivers. The Asuwa river dike was breached on the left bank about 350 m upstream from Kida bridge, at around 4.6 km and the breach was about 54 m wide (see Figs. 4 and 5). Approximately 260 ha was flooded by overflow and dike breach. Fukui Prefecture Study Group for Survey and Countermeasures of Asuwa River Flood Damage from Torrential Rains in Fukui in July 2004 (chaired by Professor Nakagawa of Kyoto University) reported the river water level as follows (Ref. 2). Through one-dimensional non-stationary analysis this study group simulated the overflow of the dike and the change of flow quantity in the river channel. Based on the results, they

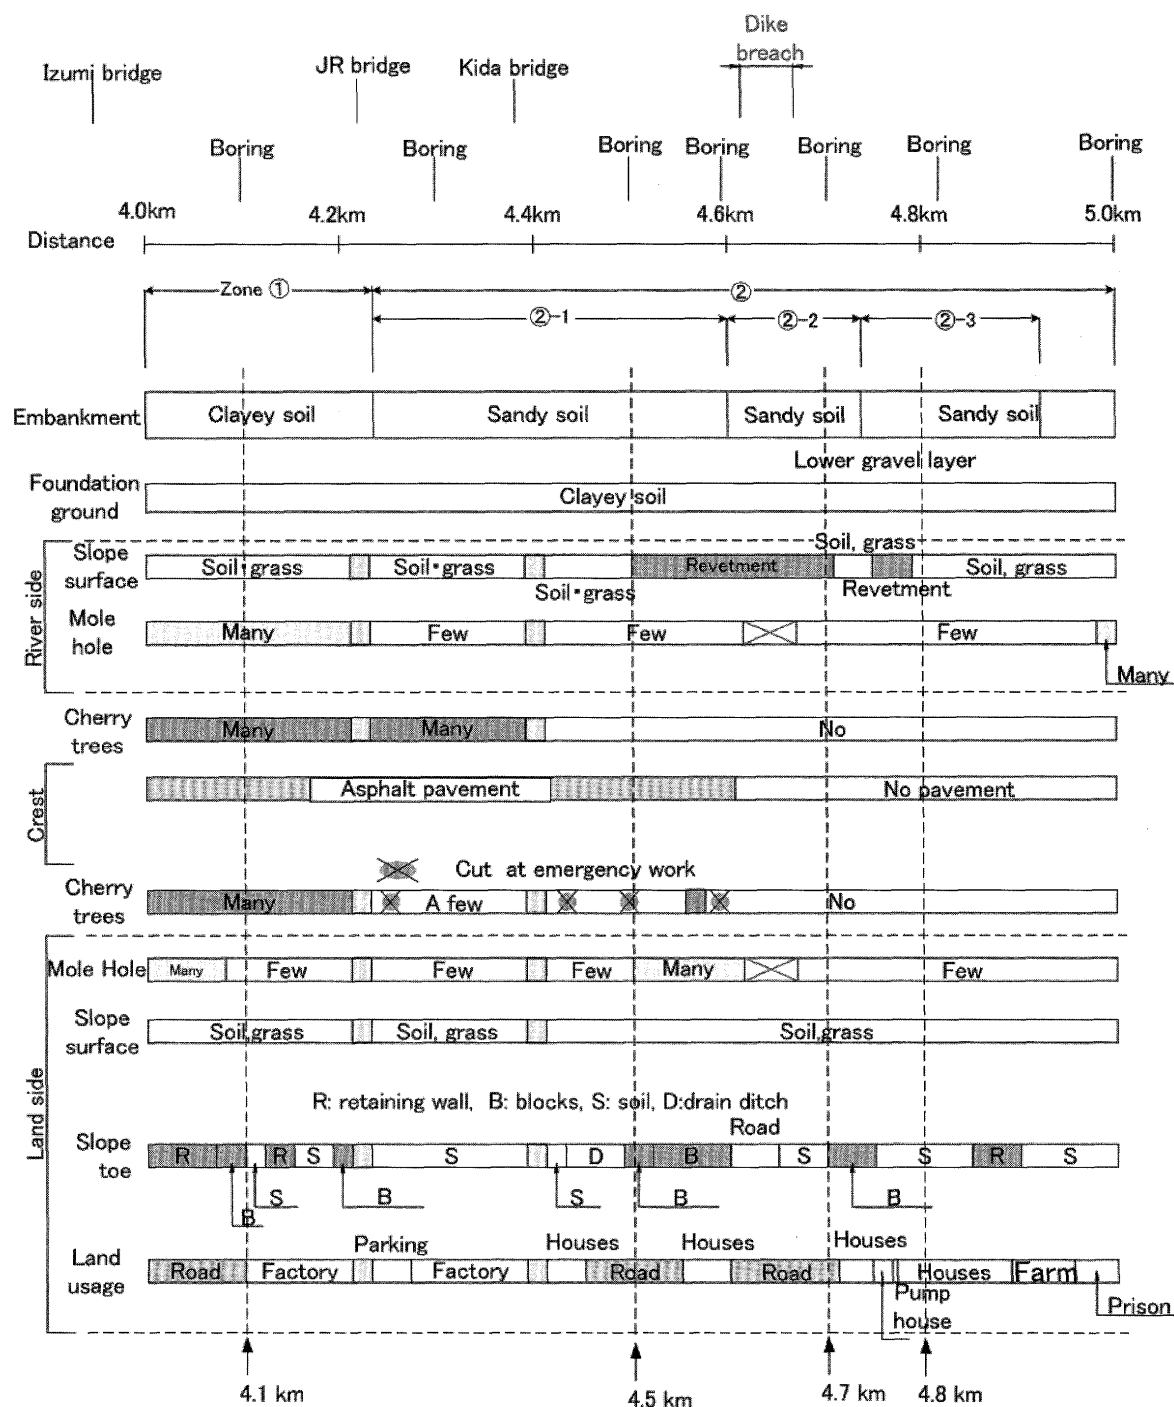
Fig. 5. Properties of dike (left bank of Asuwa river, 4-5 km)

from the fact that we observe little damage due to erosion on the surface of river side dike. The hydraulic investigation described above gives the result that the flow velocity in the river was under 2 m/s. This result means low possibility of erosion on the river side dike. Figure 5 shows the results of site survey into the structure and condition of dike. The zones in the figure indicate the different ground characteristics of the dike itself, from the results of ground investigation. Based on the ground investigation, we estimate the longitudinal and cross sections of the ground strata as shown in Fig. 6, which includes a photograph of cut surface of the dike before restoration. The main features of the survey results are summarized as follows: 1) Dike structure: The crest of the dike is paved with asphalt up to the 4.6 km point which is downstream of the breached section, but is unpaved with a surface of soil and grass above that point. The riverside revetment above and below the 4.6 km point is concrete-pitched grating crib work. The landside toe of the slope varies from place to place, between retaining wall, masonry wall, and embankment slope. In the vicinity of the dike breach there are sloping roads on the landside of the dike. 2) Dike condition: A visual survey indicated mole holes in both the riverside and landside slopes. Downstream from the 4.4 km point, cherry trees have

been planted along the dike crest. 3) Dike maintenance: Topographical features that require warning against seepage failure are a) former river channels, b) collapsed ditches and c) former collapsed ditches. A published flood control topographical chart shows that the ground topography and geology of the overflow section is largely classified into delta and that the section is not an at-risk topography in terms of a simple evaluation. From the 4.1 km point to the vicinity where the dike was breached, the Fukui prefecture study group undertook multiple borings transversely across the dike, to estimate the soil layer in this section. A number of borings were also taken around the crest of the dike breached. The study group carried out a geophysical exploration consisting of electrical prospecting and elastic wave exploration. Using these data the study group estimated ground profile in the whole section, which is shown in Fig. 6. 4) Dike soil: In the 4 to 4.2 km vicinity the dike consists mainly of clayey soil; in the 4.4 to 5 km vicinity it consists of sandy soil. The foundation ground directly under the dike is largely alluvial clay layers (Ac1), but around 5 km there are some layers of alluvial sand and gravel (Ag1). In the area of dike breach on the river side there are gravel layers which are thought to be an earlier river bed. 5) Sections studied for seepage failure: Using the data described above, a study into seepage failure was undertaken on the following 4 sections, which were classified by considering the factors behind the dike breach as given below. In Zone ① the dike ground is largely clayey soil, and in Zone ② it is largely sandy soil. Zone ② is subdivided into Zone ②-2 where the layer of sand and stones at the base of the embankment is prominent. Zone ②-1 and ②-3 upstream and downstream of Zone ②-2. The following representative sections were selected from each of the zones, considering whether or not the crest was paved and there were revetments, and whether or not the toe of landside slope was paved. The study models for 4.1 and 4.7 km sections were set mainly by using the results of borings and cut and cover study shown in Fig. 6. The models for 4.5 and 4.8 km were set by the results of geophysical prospecting, as borings were taken only for the vicinity of the crest. 1) 4.1 km vicinity: dike consisting of clayey soil, crest paved, no revetment, toe of landside slope paved. 2) 4.5 km vicinity: dike consisting of sandy soil, crest paved, no revetment, toe of landside slope paved. 3) 4.7 km vicinity: dike consisting of sandy soil, crest unpaved, revetment, toe of landside slope paved. 4) 4.8 km vicinity: dike consisting of sandy soil, crest unpaved, no revetment, toe of landside slope unpaved.

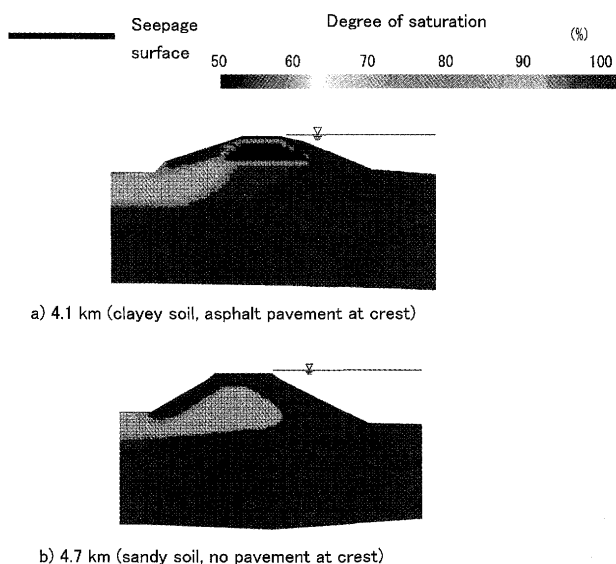
Fig. 7. Results of saturated and unsaturated seepage analysis at the maximum depth of overflow

seepage analysis was performed over the time in rainfall and flooding. Figure 7 shows a part of the results of analysis when the overflow occurs. In the analysis, overflow scouring is not taken into consideration. The dike at the 4.1 km point consists mainly of clayey soil, only very little seepage surface appears on the landside slope as shown in Fig. 7(a). In other sections including Fig. 7(b), a seepage surface was formed on the landside slope despite dike structure. Dike strength on the landside slope may

be reduced through the increase in saturated region due to the formation of this seepage surface. The dike at the 4.7 km point consists largely of sandy soil, and the dike crest is not asphalt-paved. This means that the saturated area in the vicinity of the dike crest tends to expand due to rainfall and overflow. This tendency furthers the seepage from the river channel. In this case, the saturated region reaches the toe of landside slope as shown in Fig. 7(b). This saturated region on the landside slope does not rise from the slope toe, but is formed from the surface layer, since the unsaturated regions are left from the slope toe to the dike center. The saturated region may make the soil strength decrease on the landside, which adjusts a lot of localized collapses observed at various locations. b) Stability analysis by circular slip surface method was performed in order to evaluate the stability of landside slope. The site survey confirmed dike failures seen as resulting from erosion and localized slip at several locations upstream of Kida bridge shown in Fig. 4. The seepage surface obtained from seepage analysis was used as the water level within dike for circular slip surface calculations by Fellenius method. At the riverside slope of dike, the minimum value of safety factor is greater than 1.0 and the likelihood of slip failure is small. At the landside slope of dike, the minimum value of safety factor was lower than 1.0 when the overflow depth was greatest, which is shown in Fig. 8. This is because the seepage surface had extended to the landside slope surface, and because at the 4.7 and 4.8 km points the dike consists largely of sandy soil and the crest is unpaved as stated above. There is a high possibility of slip failure on

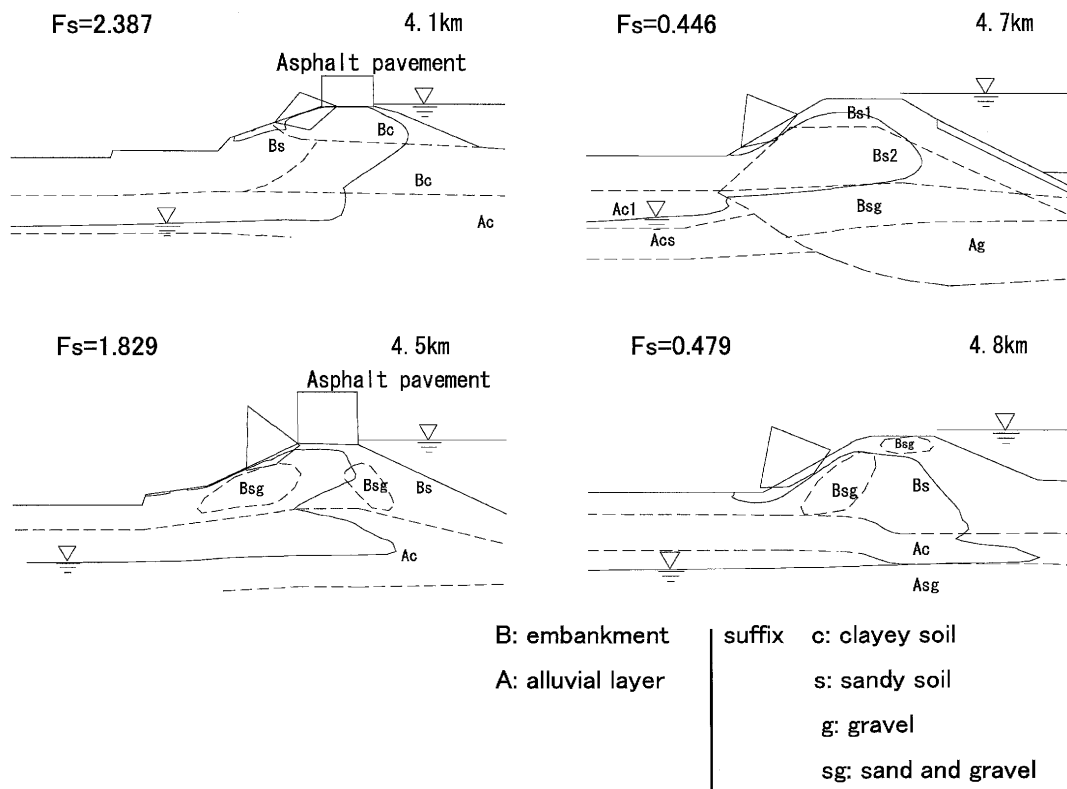
Fig. 8. Safety factor by slope stability analysis at the maximum depth of overflow

the landside slope of the dike, which adjusts the results of site survey. c) Piping damage was studied by critical hydraulic gradient calculated. In piping failure, soil particles are washed away by seepage water pressure, and pipe-shaped holes and channels are created within the dike. Since hydraulic gradient values calculated from the seepage analysis do not exceed the critical values in all sections, this suggests low possibility of piping. d) Dike collapses were studied through soil-water coupling analysis, which links the water pressure by seepage analysis and the pore water pressure by stress analysis of ground. This analysis gives a detailed understanding of the effective stress behaviour from the distribution of pore water pressure within the dike. Using the shear stress obtained from the analysis and Mohr-Coulomb failure criterion, a safety factor for each finite element was calculated as shear strength/shear stress. Locations where the safety factor was lower than 1.0 were taken as weakened regions. Also in the analysis, only seepage due to overflow was taken as an external force; overflow scouring was not taken into account. From the results, at the 4.1 km point where the dike consists largely of clayey soil, there was no weakened area that would lead to the collapse, even though there were narrow weakened regions in the surface layer around the dike crest. At the 4.5, 4.7 and 4.8 km points where the dike consists of sandy soil, the seepage area on the landside slope was large, and there was a weakened area with a strong likelihood of shear failure occurring. At the 4.7 km point there were many weakened regions on the landside slope and around the dike crest due to overflow. The actual damage and the analytical results conform well. 4) Summary: Whether or not the dike crest was paved, was a factor greatly affecting the amount of seepage flow into dike. When dikes consist of sandy soil, the seepage surface expands and may possibly lead to dike breach, depending on the length of continuous rainfall and flooding. Though weakened areas resulting from seepage were estimated from the results of survey and analysis, the extent of weakened areas was not so great that they would cause crest failure. It is hard to think that seepage failure alone could lead to dike breach. In the breached section, since the dike crest was unpaved, and since the dike consisted mainly of sandy soil, it can be inferred that seepage from the crest due to rainfall and overflow added to seepage from the riverside slope, extending the seepage area and expanding the weakened region. Considering the seepage area and weakened region, there is a possibility of slip failures and localized collapses occurring on the landside slope although the sliding layer is thin. From these results, it is thought that scouring and seepage resulting from overflow caused a weakening of resistant properties against scouring on the landside slope, and that stronger scouring occurred together with slip failures and localized collapses. The progressive effect of these multiple factors is seen as likely to have led to dike breach.

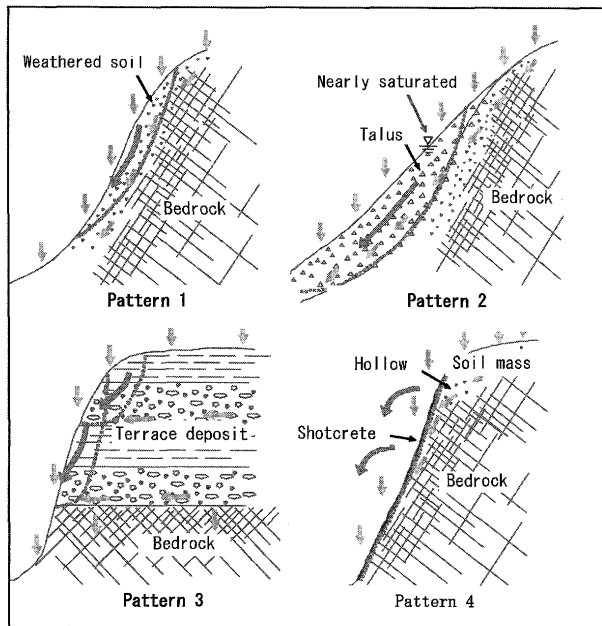
Fig. 13. Patterns of slope failure

The total number of slope failures investigated is 33, which is classified into 4 types according to failure patterns as illustrated in Fig. 13. Pattern 1 failure is caused in the rock mass with significantly weathered surface soil, and which mainly consists of easily weathered pyroclastic rock or andesite. Pattern 2 is the failure of scree, which is caused in the talus deposit. In some cases, the failure occurs in comparatively gentle slope or in large-scale slope; some planted big cedar trees completely fall down; the slope is located in catchment topography with some spring points. The whole stratum

is nearly saturated by rising of groundwater and/or by forming of saturated zone from the surface due to rainfall, followed by failure like mud flow in which the moving distance of soil mass is long. Pattern 3 failure is caused in the terrace deposit on bedrock or at around layer boundary within terrace deposit, in which the pervious boundary becomes weak plane. Pattern 4 failure is the peeling off of shotcrete spraying work, which is caused by the water pressure behind separated shotcrete, although weep drains on the shotcrete are available. The bedrock consists of significantly fissured soft rock with soil mass at the top. In some cases, the hollow behind shotcrete has existed formerly.

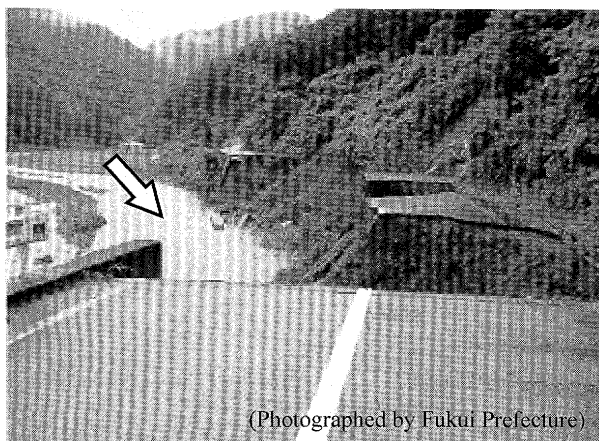
**Photo 1.** National road 157 at Nakajima in Ohno city was closed because the outer side of curved river embankment collapsed

revetment collapses and ground scouring behind revetments, which in turn caused road shoulders and hard surface to be washed away (for instance, *see* Photo 1). In the mountain districts, damage was concentrated on roads on embankments located in valley sections, and flooding that occurred along the valleys is seen as causing collapses of ground supporting road beds (for instance, *see* Photo 2). 2) Characteristics of damage to road bridges: There were many cases of damage to road and pedestrian bridges leading to collapse. No bridges along major highways collapsed, and so there was little effect on traffic flows. The form of damage to bridges is classified into the following 4 types, based on subsequent bridge performance: a) Impact or accretion of debris to upper structure, b) Scouring of foundation ground of lower structure, c) Collapse of upper structure due to failure of lower structure, d) Upper structure washed away (for instance, *see* Photo 3). Differences in damage are seen as due to the depth and velocity of the flood waters. The degree of damage was particularly noticeable at locations where river flow became discontinuous, such as at abutment positions and points where smaller rivers

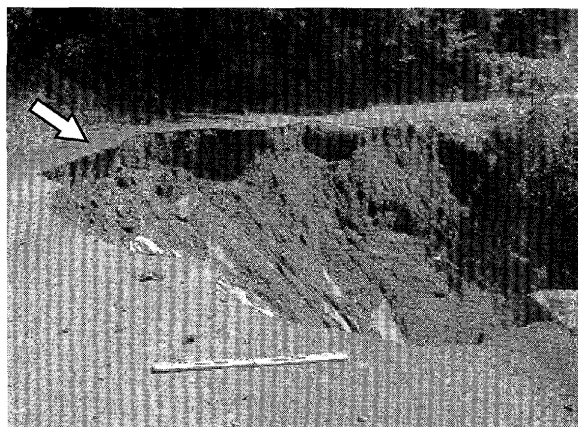
**Photo 2.** Prefectural road 34 near the Houkyouji temple in Ikeda town was closed because the flow of rainwater went through from upper part of valley to drainpipe under the road

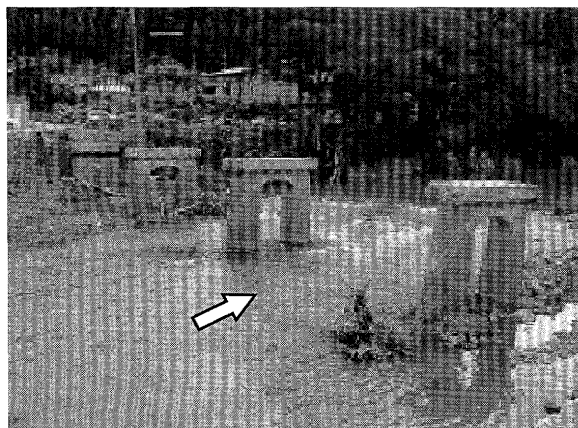
**Photo 3.** Superstructure of Kawahara bridge in Miyama town was completely washed away

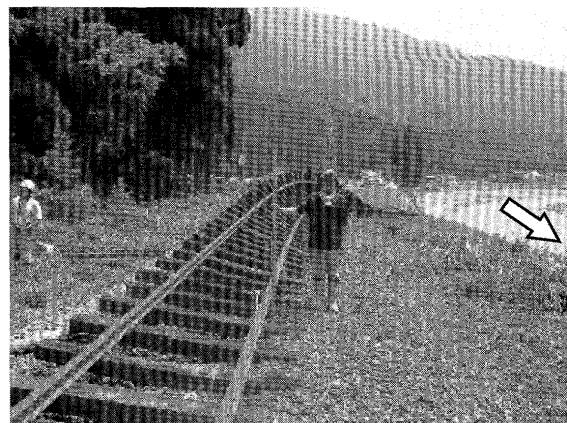
**Photo 4.** Rails and sleeper were moved toward the river due to the overflow at Shinagase in Miyama town

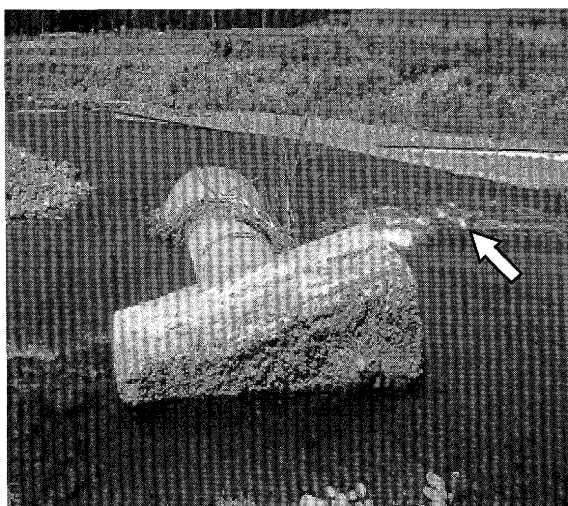
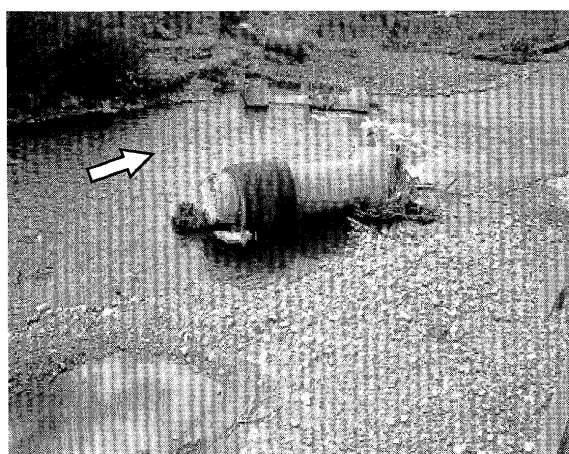
**Photo 5.** The 5th Asuwa river railroad bridge collapsed due to flood: The 2nd pier fell down and some gravels of riverbed adhered to the bottom of footing and the 3rd pier was broken at the joint of footing

join, and at water flow impact sections created by the shape of the river. 3) Rail beds: Damage is classified into two groups. One is damage to track, such as shifting rails, ballast washed away. The other is collapse of embankment or retaining wall supporting the track. A characteristic aspect was that many cases of damage occurred at locations close to level crossings, such as mud deposited around rails, ballast washed away or collapse of retaining walls. Similar damage was seen around culverts built at the bottom of embankments for tunnels or drainage. This damage may be caused by the violent water flows generated because level crossings and culverts became water courses at the flooding time. In addition, rails shifted largely at several locations of level ground, which was seen as the effect of powerful water flows and also the buoyancy of timber rail sleepers (for instance, *see* Photo 4). 4) Damage to rail bridges: Of the 7 bridges on the JR Etsumi North Line in this area, 5 bridges collapsed. Bridge collapses took the two forms; tipping over with foundations and fracturing of supports (for instance, *see* Photo 5). No differences were identified in forms of collapse due to differences in foundation ground, and no differences were found in the degree of damage due to bridge length or number of spans. At bridges collapsed, river water levels are estimated to have reached the bridge girders or the top of the bridge girders. At bridges that did not collapse, water levels are estimated to have reached only the lower surface of the bridge girders even at their highest, because the bridges were located in places where the river or its valley was wide. To study the factors behind bridge collapses, we made stability calculations against tipping and stress calculations of bridge supports which were based on road bridge specifications, considering the effect of flow pressure as water levels reached the top of the bridge girders. The results obtained from this study showed that normally stable bridges tipped over in the case where embedding of footing was shallow, or fractured in the case where the embedding was deep, when the rains on this occasion caused the water to rise over the bridge girders.
