GROUND DAMAGE RESULTING FROM TORRENTIAL  
RAINS IN FUKUI, JULY 2004THE JAPANESE GEOTECHNICAL SOCIETY: EMERGENCY SURVEY TEAM FOR GROUND DAMAGE  
RESULTING FROM TORRENTIAL RAINS IN FUKUI, JULY 2004

Torrential rains in Fukui, July 2004 resulted in heavy damage to ground in the Asuwa river basin. This paper reports an outline of the matters and causes of the following damage: 1) The dike in the lower reaches of Asuwa river was breached in city area. A detailed survey was undertaken to determine why the dike was breached at that location. 2) Many cases of damage to revetments were observed in the upper reaches of Asuwa river and its tributary streams, and the damage was worsened by inundation resulting from timber debris and sedimentation. There were many cases of slope failure above revetments, which were thought to be due to scouring. 3) Many slope failures occurred at locations distant from rivers. In many cases they were relatively shallow collapses. 4) Many mud and debris flows occurred along small rivers or in mountain valleys, and large quantities of mud and timber were displaced. 5) At five steel bridges on the JR Line, bridge girders were washed away and bridge supports collap

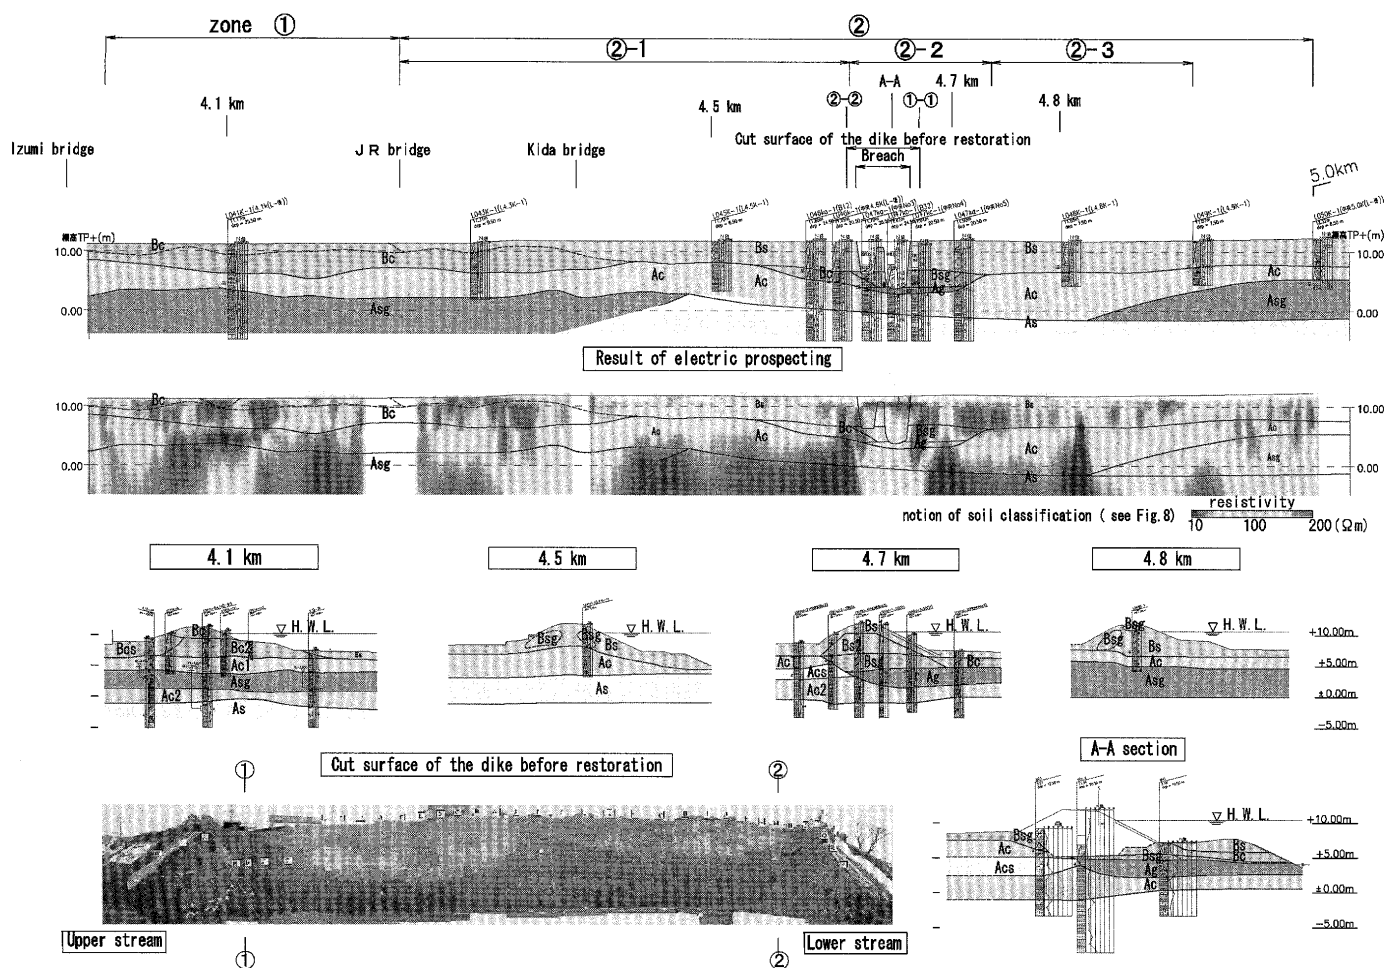
Fig. 6. Results of geotechnical investigation (left bank of Asuwa river, 4-5 km)

from the fact that we observe little damage due to erosion on the surface of river side dike. The hydraulic investigation described above gives the result that the flow velocity in the river was under 2 m/s. This result means low possibility of erosion on the river side dike. Figure 5 shows the results of site survey into the structure and condition of dike. The zones in the figure indicate the different ground characteristics of the dike itself, from the results of ground investigation. Based on the ground investigation, we estimate the longitudinal and cross sections of the ground strata as shown in Fig. 6, which includes a photograph of cut surface of the dike before restoration. The main features of the survey results are summarized as follows: 1) Dike structure: The crest of the dike is paved with asphalt up to the 4.6 km point which is downstream of the breached section, but is unpaved with a surface of soil and grass above that point. The riverside revetment above and below the 4.6 km point is concrete-pitched grating crib work. The landside toe of the slope varies from place to place, between retaining wall, masonry wall, and embankment slope. In the vicinity of the dike breach there are sloping roads on the landside of the dike. 2) Dike condition: A visual survey indicated mole holes in both the riverside and landside slopes. Downstream from the 4.4 km point, cherry trees have

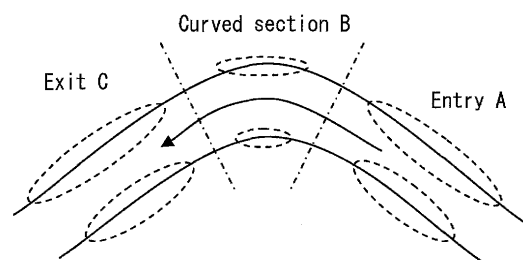
Fig. 9. Classification of the failure points in the bending channel

The classification of damage causes made here, is not based on actual observation but the river section charts in the report. When water levels at the flooding time exceeded the revetment crest height in the report, crest failure was considered as the primary cause. However, it is estimated in many cases that river bank erosion occurred once the crest failed. There are also many cases where river bed scouring may have prompted bank erosion. When multiple causes are considered possible, the number of causes is higher than the number of cases of damage. Particularly the proportion of bank erosion becomes high. Also in Fig. 9, we count in duplicate when the location of damage straddles different sections, for instance, from entry A to curved section B. Figure 10 indicates the following features. 50% of damaged revetments and dikes are on outside banks of curved sections, 33% are inside banks and 17% on straight sections, thus the damage in curved sections, on both inside and outside banks, accounts for over 80% of the total. 62% of the damage on outside banks was damage to exit C, while only 15% was damage to entry A. On inside banks, 44% was to entry A and 40% to curved section B, while only 16% of the damage was to exit C. The 6 charts that compile the causes according to location, show that overall, bank erosion accounts for between 50% and 70%. Besides bank erosion, on outside banks the proportion of river bed scouring is high, while on inside banks the proportion of crest failure is high. On entry A, the proportion of crest failure is high for both inside and outside banks. On curved sections B, bank erosion accounted for about 70% for both outside and inside banks, and this was higher than for both entry and exit sections. In many cases on outside banks, river bed scouring led to bank erosion, while on inside banks crest failure led to bank erosion. Crest failure accounts for a relatively high proportion of damage in straight sections.

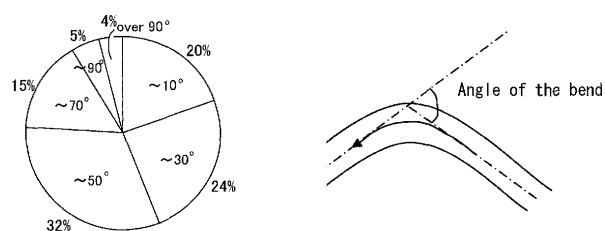
Fig. 11. Ratio of damaged channels categorized by the angles of the bend

The rivers damaged in the upstream areas, are located in flat valley floors, and almost all river channels are dug in. River levels therefore rose suddenly due to the torrential rains, and extensive areas were inundated by flood water that could not be carried downstream. In classifying the causes of revetment collapse, the mechanism of crest failure is as follows. The crests were damaged by overflow, and the revetment damage took the form of backfill soil escaping. In almost all cases we think that the crest failures occurred from the multiple effects including bank erosion. When inundations occurred at almost all locations in the river basin, the proportion of crest failures tends to become higher. In areas where rivers make sweeping curves, muddy flows ran outside of river channels. This may make the proportion of crest failures become higher, because particularly for the inside banks the form of the damage was as if the revetment had been peeled off the crest. In many cases, on the outside banks secondary flow has the effect of deep scouring and river bed scouring tends to occur. For every position on outside banks, the proportion of river bed scouring is about 20%, which is high compared with inside banks. A plot of flow velocities in curved sections

shows cases where, depending on the degree of curvature, velocity on the outside bank side increases due to the secondary flow effect, and also cases where velocity increases intermittently on the outside bank side at the exit. By contrast on the inside bank side, in many cases the velocity is higher than on the outside bank from the start of the curve to the midpoint, and the velocity gradient also increases with the curve. On the outside bank side, the number of failures in the vicinity of the curve exit accounted for 60%, while on the inside bank side, the number of failures from the curve entry to the midpoint accounted for 80%. The high velocity of the river's inundating flow or the velocity gradient can be seen as having a large effect on the revetment damage. Figure 11 shows the angles of individual curves and the proportions of cases of damage. Curvature angles were taken as the angle at the intersection of two straight lines extended from the straight lines of flow on either side of the curve as illustrated in Fig. 11. Damage locations in straight sections are included with those of curvature angles of 10° or below. Up to 50°, the larger the curvature angle, the greater the proportion of cases of damage. Above 50°, the number of such steep curves declines, so the proportion of cases of damage also declines. A survey should be made of the proportion of damaged sections to non-damaged sections for various curvature angles, but in the present case an extremely large number of small and medium-sized rivers were studied, and it was difficult to go to the site and to measure the curvature angles of undamaged sections. In the case of the torrential rain damage in the Higashi Seto region in July 1974 caused by Typhoon No. 8 and the seasonal rain front, a study team from Kyoto University surveyed in detail the curvature angles and the proportions of damage for all the river channels of Shin river and Houju river in Awaji island (Ref. 7, 1974). This study confirmed that, for Shin river for which the average curvature angle was not so great, the greater the curvature angle, the higher the rate of damage, and the ratio of damage on the outside bank was particularly high. For Houju river which had a higher average curvature angle, no clear correlation could be identified between the curvature angle and the ratio of damage. Nevertheless, the overall ratio of damage for Houju river was evidently much higher than for Shin river, showing that the steeper the curves there are in a river, the greater the ratio of damage. The rivers in the upper reaches affected by this Fukui rains, had many curved sections, which is seen as linked to the increased

number of cases of damage. As Fujita et al. (1989) have reported for the upper reaches of rivers, when damaged revetments are restored, they are in many cases damaged again in the following flooding event. We should remember case studies on this occasion and in upper reaches with many curved sections it is necessary to be prepared for flood damage whatever type of revetments are in place.

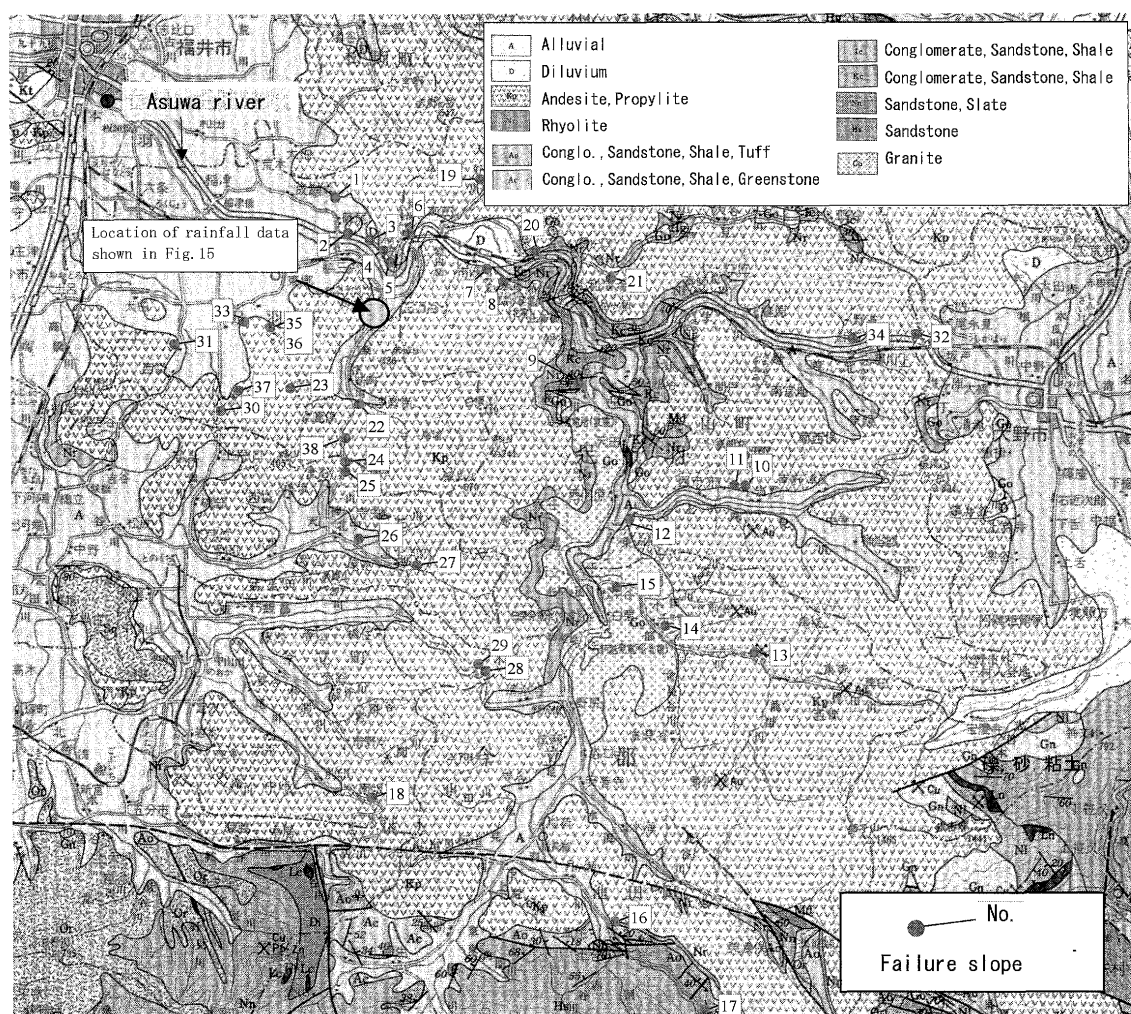
Fig. 12. Sites of slope failure

Our survey team examined slope failures that occurred in the basin of Asuwa river shown in Fig. 1, which is located in the Echizen central mountain area. Figure 12 shows locations of slope failure investigated and a geological map of the region. In this mountainous region there is a distribution of Funatsu granite (older granite) and conglomerate, sandstone and mudstone of the Tetori and Asuwa groups of Jurassic-Palaeogene. They are widely covered by types of andesite of Itoo formation of the Neogene. At the boundary between the mountains and plains there is a distribution of terrace deposit of

Diluvium, and talus deposit of Diluvium and Alluvium. Most of the failures on this occasion occurred in the Itoo formation area. The Itoo formation belongs to the so-called Green Tuff, and it can easily be weakened because of hydrothermal alteration. In many cases it forms deep weathering crust, and it is not unusual for the depth to exceed 10 m. Also, large numbers of lineaments have been identified in the Echizen central mountain area. In places where the gentle slopes around lineaments have been excavated by steep gradients, failures occur even with ordinary heavy rain.

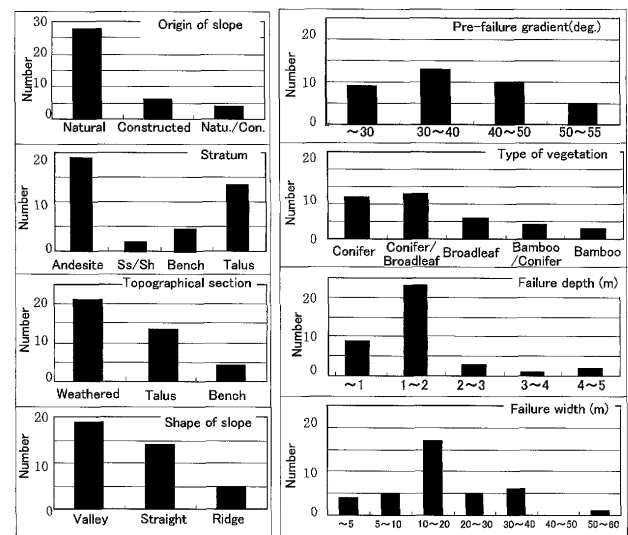
Fig. 14. Factors affecting slope failure

The actual number of failures of pattern 1 is 15, pattern 2: 13, pattern 3: 3, and pattern 4: 1. Figure 14 shows the frequency distribution charts for 8 items: origin of slope, stratum, topographical section, shape of slope, pre-failure gradient, type of vegetation, failure depth and failure width. Only the whole distribution chart is shown and the chart for each pattern is omitted here. The constructed slope category in Fig. 14 means features such as excavations, embankments, structures, etc. The slope gradients and sizes of failures are outline values. Slope shapes are judged from observations at the site survey. Of the hills in the topographical areas, where there are thick distributions of talus or scree deposits, they are referred to as talus and the remaining hill areas are referred to as weathered soil. As for types of vegetation, cryptomeria, pine and cypress are all called conifer. Locations where there are bamboo and cryptomeria, are shown as bamboo/conifer, and bamboo only is shown as bamboo. A summary of the survey results is as follows: 1) Origins of slopes: Slope failures examined in this survey occurred almost entirely on natural slopes. Cases of damage to constructed slopes are thought to have been few in number because their

gradients are stable and suited to structures or the land configuration, and because unstable surface soil is cleared and measures to handle surface water are already in place. 2) Strata and topography: Almost all failures were of weathered soils or taluses. The failures of weathered soils were mostly in the andesite areas. In the region concerned there are also areas of granite, but no cases were identified of surface layer failure of so-called masado. Granite is found in limited areas on both banks of Asuwa river. Simply stating, granite distributes in the banks of Asuwa river which are in an area of low elevation where slopes are steep, while andesite is found in an area of high elevation where slopes are gentler. As a result, weathered granite is constantly being eroded and carried away, and there may be nothing to offer on this occasion. Andesite, normally highly stationary, may be washed away all at once on this occasion. 3) Shapes of slopes: Failures occurred frequently in the order of valley-type slopes, straight line type and ridge-type. These results are seen as reflecting the general and empirical trend that slope failures brought about by torrential rains may occur easily in configurations collecting water. Comparing different failure patterns, weathered soil failures occurred irrespective of whether the slope was a valley- or straight line type, but talus failures occurred most often in valley-type slopes. 4) Pre-failure slope gradients: Weathered soil failures occurred irrespective of slope gradient, whereas talus failures tended to occur on relatively gentle slopes. This may be because there are more gentle deposited slopes of talus rather than weathered soil. 5) Width and depth of failures: Failures of weathered soil largely had widths in the 10~20 m range and depths of 2 m or less, whereas widths and depths of talus failures ranged more widely, with some relatively deep failures of 3 m or more. Rocky ground has low permeability, but to a depth of 2 m or so below the surface there is considerable void content due to roots, etc., and permeability is relatively good. Thus, surface water percolates easily and torrential rains

produce a saturated zone, and as a result failure depths were concentrated around 2 m or less. By contrast, permeability is good in locations of talus, so the depth of the failed layer corresponds to the thickness of the talus layer and may be greater than with weathered soil. 6) Types of vegetation: Failures of weathered soil occurred regardless of vegetation type, whereas talus failures occurred where there was cover of coniferous trees and also mixed woodland of coniferous and broadleaved trees. However, overall, no clear cause and effect could be identified with vegetation type.

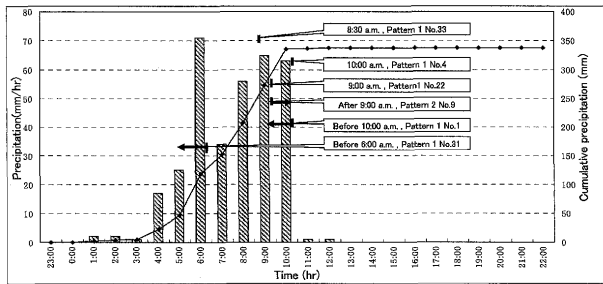
Fig. 15. Precipitation at failure time (location for monitoring rainfall is shown in Fig. 12)

A determination of failure time was made from among all the locations of slope failure above. A majority of the locations were not close to houses, and so six locations were selected for inquiries to determine the time when failures occurred. Figure 15 shows rainfall data with the times of failures occurred. The rainfall data are for Kidonouchi, Fukui city, which is close to most of these six locations. In the case of the slope failures resulting from the torrential rains, the effect of previous rainfall is discounted, and the failures are thought to have been caused by seepage water from the ground surface resulting from intense rainfall in a short period of time. From the survey of failure time, it is estimated that five out of the six failures occurred after the cumulative rainfall exceeded 250 mm.

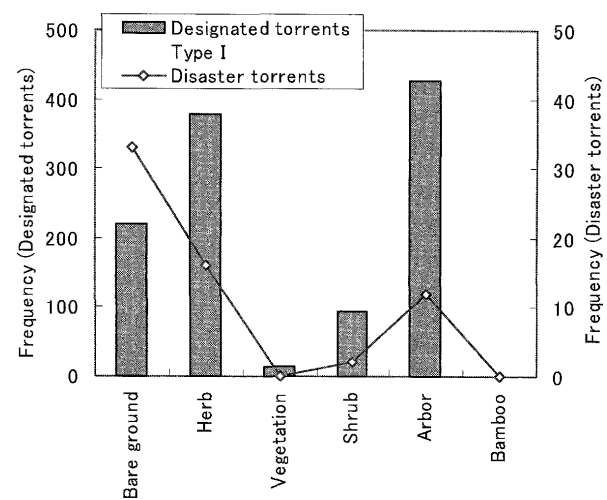
Fig. 20. Vegetation around the torrent beds

topography or soils could be identified. Next, a study was made of debris flows and the vegetation in the surrounding area. Figure 20 shows vegetation in areas surrounding valley floors. The bar graph of overall distribution around torrents at risk of debris flows is in the order of trees, grass, and no vegetation, but at locations where debris flows have occurred actually, it can be seen that in a significantly large number of cases there is no vegetation. Many debris flows in places having no vegetation, may indicate the unstable nature of the material deposited by those torrents, and it can be inferred that many debris flows occurred this time at sites where past shifts have occurred of the valley floor. In Fig. 21 the horizontal axis represents anticipated volume of debris released at points where debris flows have occurred actually this time, and the vertical axis represents actual volume of debris released, plotted for each type of surrounding vegetation. Vegetation on streams where debris flows have occurred, was taken from a Fukui prefecture vegetation distribution map. More than half is shown to be forested cryptomeria. From the map, for pine/cryp-

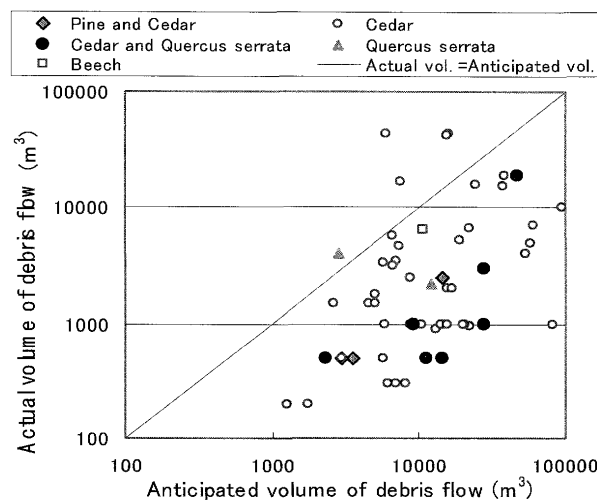
Fig. 21. Effect of surrounding vegetation to the volume of the debris flow

tomeria and cryptomeria/quercus serrata, the proportion of released mud is low compared with anticipated mud. The proportion released for quercus serata and beech is higher, although there are not many data. However, from the data it is difficult to conclude that the volume of mud released is higher or lower for a specific type of vegetation. As a result, we cannot find specific trends between the distribution of topographical and geological features and vegetation for valleys at risk of debris flows, and a distribution of locations where debris flows occurred actually, except vegetation around the valley floors. A study was made of the correlation between basin area and river floor gradient with the area inundated, etc., but it is omitted here. At last, the relationship between time of occurrence of debris flows and rainfall was studied. Figures 22 through 24 are so-called snake curves showing the relationship between accumulated rainfall and strength of rain at the location of debris flows for Fukui city, Miyama town and Sabae city. Answers to a questionnaire survey on the time of occurrence of debris flows, were averaged for each locality and used as the time debris flows occurred for each stream. The rainfall at that time was marked on the charts with arrows. The

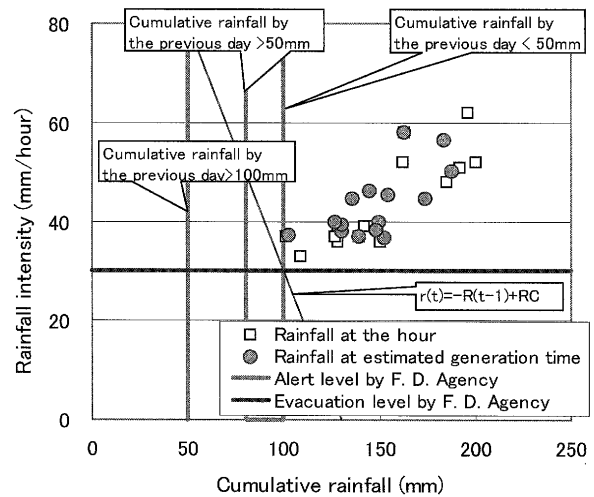
Fig. 25. Alert and evacuation rainfall criteria

warning stance (announcements to prepare for evacuation and evacuation orders) is taken. The straight line shown as  $r(t)$  in Fig. 25 is set to the debris flow danger criterion line from Ministry of Construction guidelines for when accumulated rainfall passes 100 mm and heavy rain 30 mm/hour. The debris flows on this occasion all fell in the range in which warnings were necessary according to either one of the above criteria. At least it is concluded that the first debris flow to have occurred was in no sense exceptional from the rainfall conditions. As shown in Figs. 22 through 24, after the occurrence of the first debris flow, rain continued to fall more heavily even than before, with rainfall of about twice the criteria level continuing for several hours. Finally accumulated rainfall reached about three times the criteria level, or around 300 mm. Debris flows occurred continuously in waves, releasing large quantities of mud and floodwater with the likelihood of causing considerable damage.
